## **6 Mile/Canyon Creek Landscape Analysis**

**USDA FOREST SERVICE  
CHUGACH NATIONAL FOREST**

**SEWARD, ALASKA  
2002**

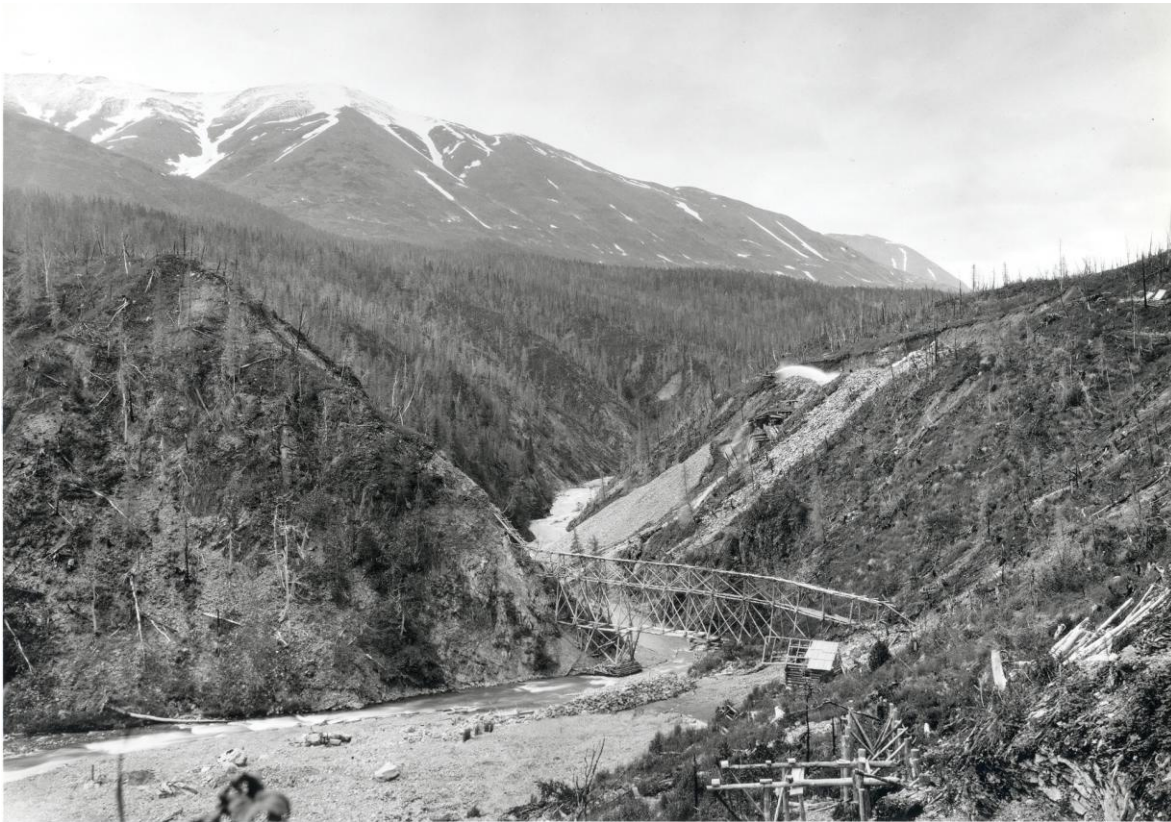
Figure 3. This photo is Wible on Canyon Creek, 1904. Photo shows high gravels on the right. The trestlework formerly carried a flume.

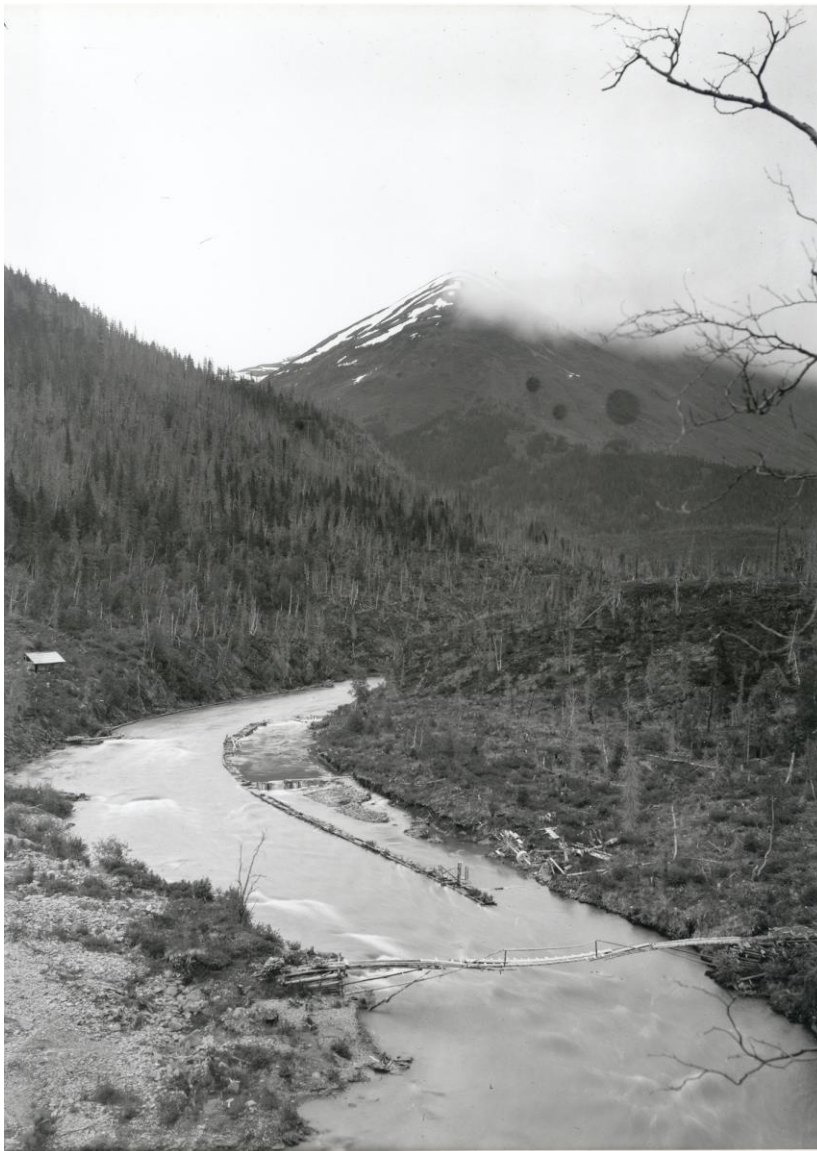
**Figure 4. East Fork Sixmile Creek in 1904. Wing dam on right. Moffit, 1906**

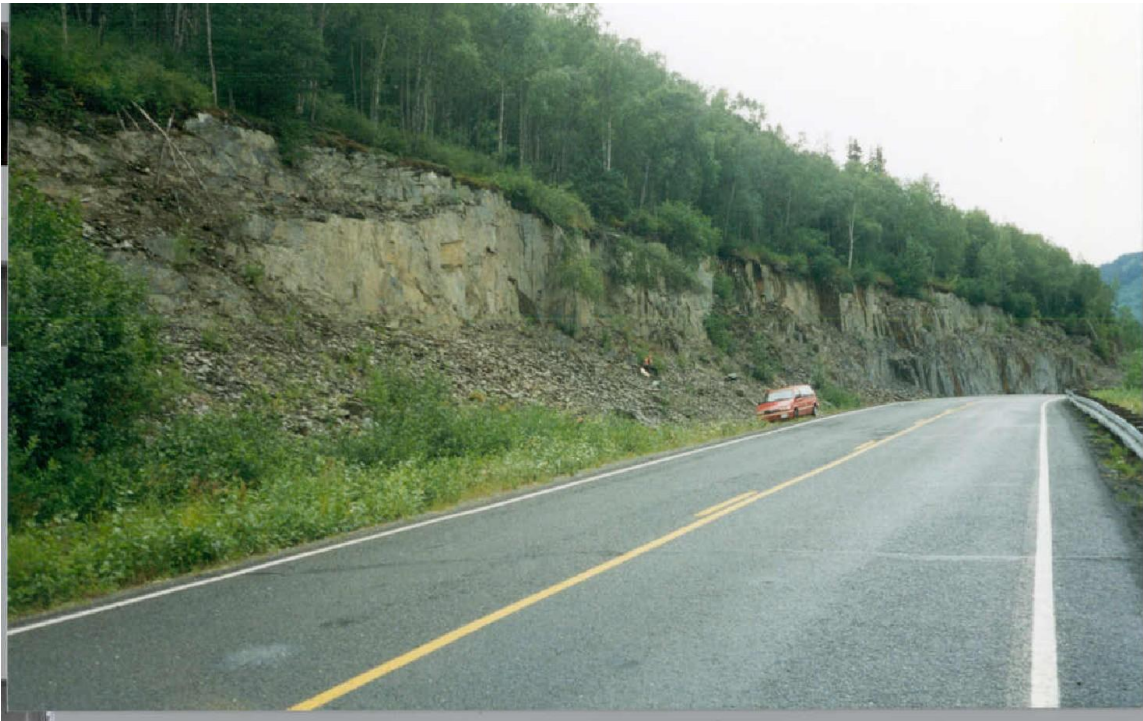
The outcrop is nearly vertical with an apron of talus. The talus angle of repose is about 30 degrees. The flat, thin nature of the material tends to allow it to slide/move easily, thereby not retaining a steep slope. “New” rock comes down mostly in the spring, in response to freeze/thaw forces. Heavy rains may cause some loose rock to migrate downward.

Figure 8. Slate rock source at mile 2 of the Hope Highway. Photo taken by Carol S. Huber, looking west toward Hope.

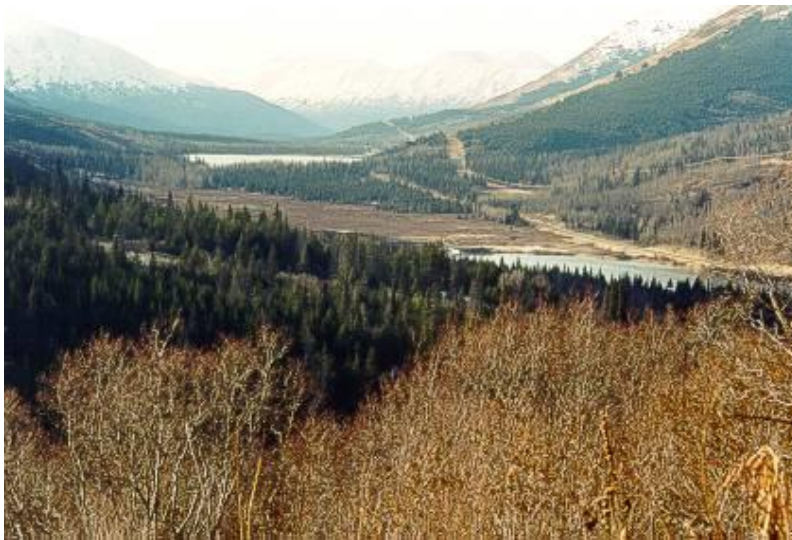
**Figure 2.II.B-1:** Upper and Lower Summit Lakes, in the southern portion of the Canyon Creek watershed, looking toward the south.

**Canyon Creek:** Much of Canyon Creek is incised into a narrow gorge at the bottom of a glacially carved valley. This deep canyon was created as Canyon Creek eroded downward to the level of the East Fork Sixmile Creek valley, a deeper valley carved by a larger glacier. Below the confluence with Mills Creek, all of Canyon Creek is classified as a Moderate Gradient Contained Narrow Valley Channel (LC2). This channel is confined by steep canyon walls and includes numerous waterfalls and cascades. Between Upper and Lower Summit Lakes, Canyon Creek is classified as a Narrow Low Gradient Flood Plain Channel (FP3), a sinuous, low gradient channel with low velocities and low sediment transport capacity. Upper and Lower Summit Lakes function as settling basins for sediments transported by the uppermost tributaries of Canyon Creek (**figure 2.II.B-1**), although most sediment input occurs downstream of these lakes.

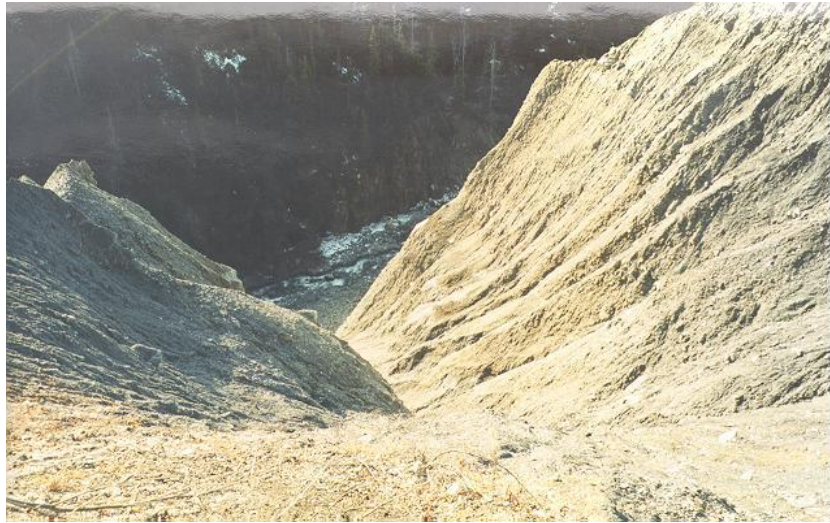
**Figure 2.II.B-2:** View looking down steep eroding slope into Juneau Creek. This contributes considerable sediment to the channel during snowmelt and rainstorms.

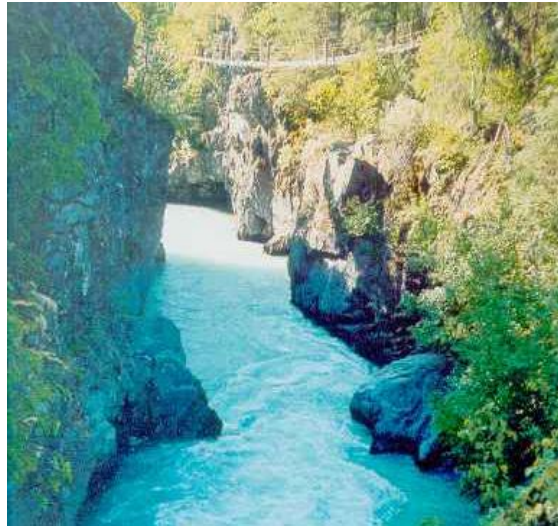
**Figure 2.II.B-3:** East Fork Sixmile Creek gorge, near Gulch Creek.

**East Fork Sixmile Creek:** Because it occupies a large, glacially carved valley, East Fork Sixmile Creek is predominantly a Wide Low Gradient Flood Plain Channel (FP5) and has a lower overall gradient than Canyon Creek. However, upstream of the confluence with Canyon Creek, East Fork Sixmile Creek enters a small gorge and is classified as a Moderate Gradient Contained Narrow Valley Channel (LC2) and a Deeply Incised Contained Channel (MC3) (**figure 2.II.B-3**). East Fork Sixmile Creek has three significant tributaries. Granite Creek, originating on Turnagain Pass, and Bench Creek, originating on Johnson Pass, are both predominantly Low Gradient Flood Plain Channels (FP3, FP4, and FP5). Center Creek is a Low Gradient Flood Plain Channel in its lower reaches.

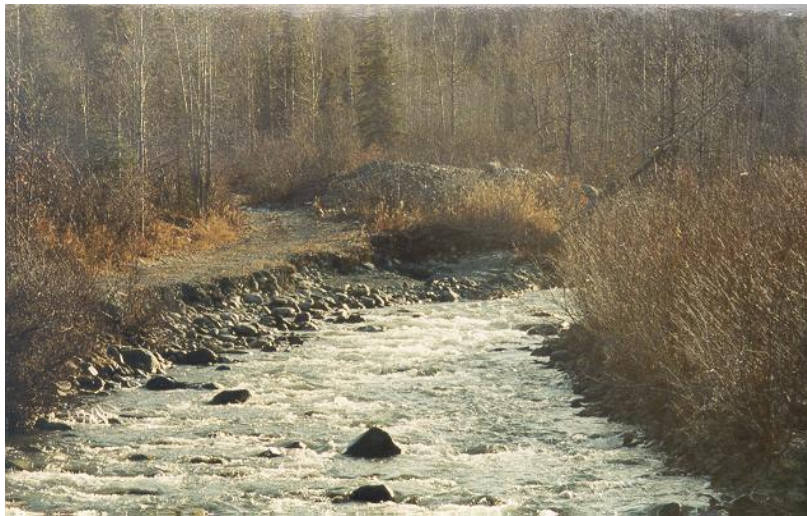
**Figure 2.II.B-4:** Placer mined channel of Canyon Creek.

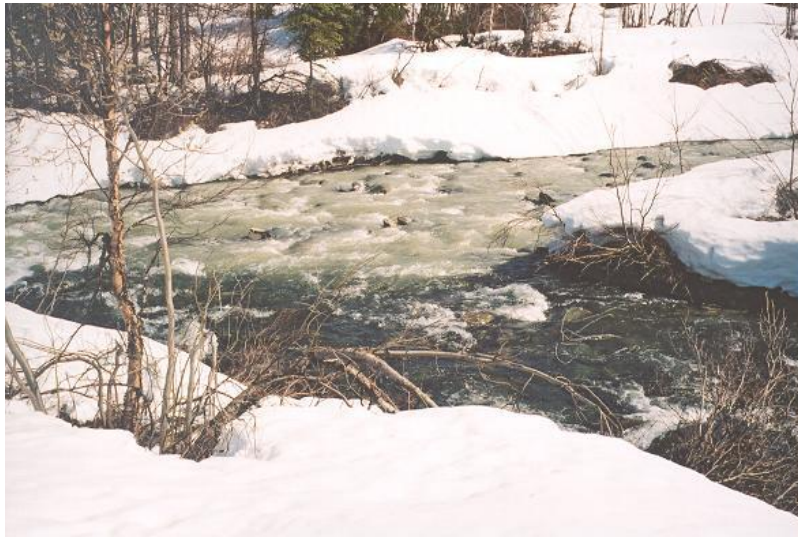
**Figure 2.II.B-7:** Confluence of Mills Creek and Canyon Creek. Mills Creek, in the background, is significantly more turbid.

In 1980, water quality data were collected upstream and downstream of the Mills Creek Development Company claim located on Mills Creek at approximately 1500 feet in elevation (Blanchet, 1981) (**table 2.II.B-5**). These water quality data include physical water quality parameters as well as heavy metal concentrations. Silt loads in Mills Creek are naturally elevated, the result of sediment input from the movement of small glaciers near the headwaters, but turbidity can also be affected by placer mining operations. Turbidities measured upstream and downstream of the Mills Creek Development Company Claim in 1980 indicate that at times, Mills creek carried more sediment downstream of the mining, even though this site used a relatively efficient pair of settling ponds to remove sediment from the water. One pair of samples shows an increase in turbidity from 2.7 NTU upstream of the mining to 29 NTU downstream of the mining. This increase of 26 NTU exceeds the state standard that allows for no more than a 25 NTU increase above natural levels in fish-bearing streams (ADEC, 1999).

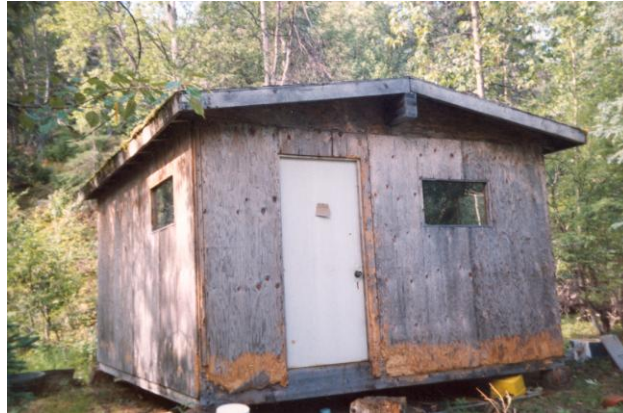
Figure 9. Recent cabin at Whites Roadhouse complex, on Lynx Creek

recorded status. The camp appears to be a mix of historic and more recent cabins/structures. The five cabins appear to be used as a hunting camp rather than for mining purposes. In the past, the Seward Ranger District posted these cabins as government property but the claimants removed the signs and currently hold possession of them. There is no approved plan of operations or any other authorization for use of these structures.

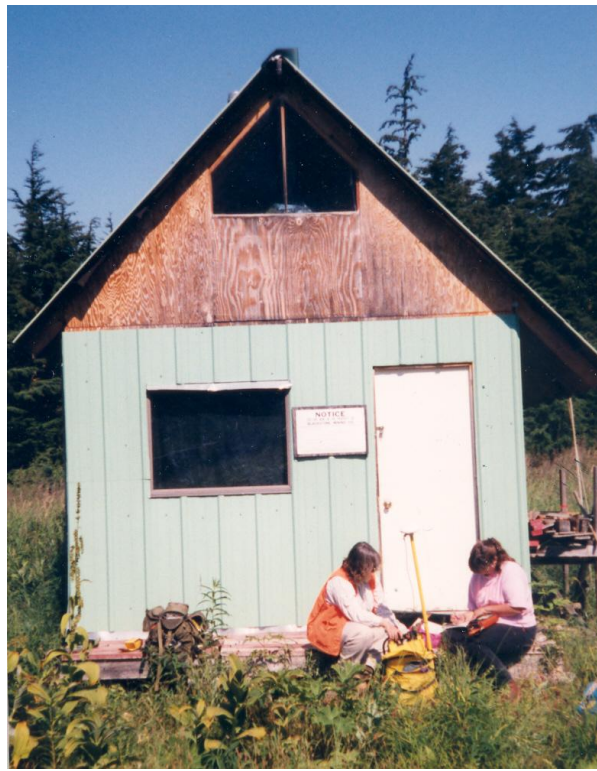
Figure 10. Jacobs cabin on Lynx Creek. Carol Huber, Forest Geologist, on the left and Ann Allen, U.S.D.I. Bureau of Mines, on the right.

Farther upstream, there are two more cabins. Both are along the old access road (shown on the topographic map) on the east side of the creek. Jacobs cabin is in NW1/4 Sec. 16, T. 7 N., R. 1 E., of the Seward Meridian. It is a plywood cabin with green metal siding and glass windows. It is covered by the “Discovery 3” mining claim located Sept. 16, 2002, by Thomas Mobley, Brad Sathers, and Gerald Lauer; it is in recorded status. John Rader was the previous claimant; he may have built the cabin. Since the current claim was located in 200, the Forest Service may own this cabin. The silver cabin is farther up the creek; it is in the SE1/4 Sec 17, T. 7 N., R. 1 E., of the Seward Meridian. It is covered by “Legal” mining claim, located Oct. 6, 1956 by Matthew Rader and John Rader; it is in recorded status. Ownership of the silver cabin probably lies with the claimants. There is no approved plan of operations or any other authorization for use of Jacobs Cabin or the Silver Cabin.

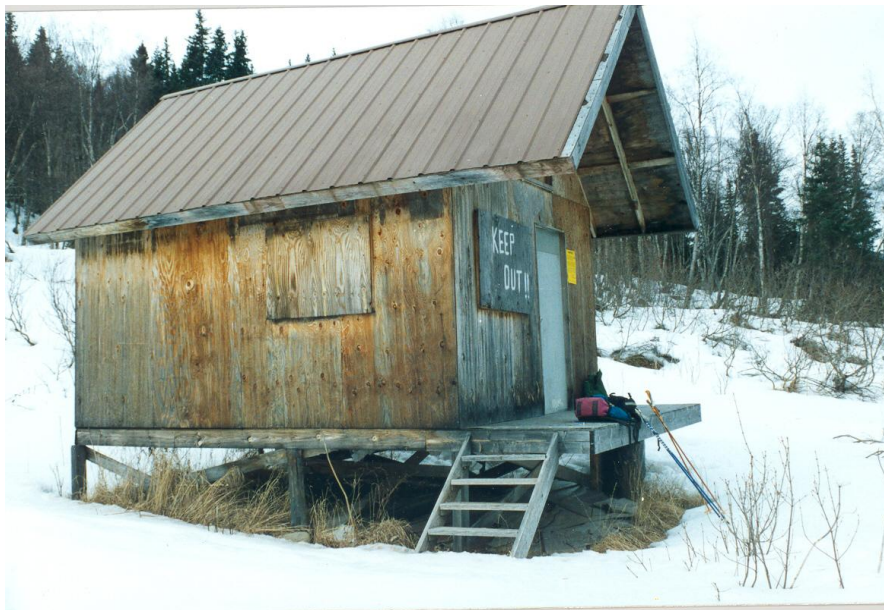
Figure 11. New Heavens Gate cabin on Canyon Creek.

There are actually 2 cabins on the Heavens Gate claim; there is an old collapsed cabin and a newer cabin built by the claimants Mark Gaede and Gary Lindman in the summer of 1982 (Voss, 1992). The Heavens Gate cabins are on the east side of the Seward Highway at about mile 53, in the NE $\frac{1}{4}$  Sec. 33, T. 8 N., R. 1 W., of the Seward Meridian. The cabins are on the Heavens Gate #2 mining claim, which was located, Feb. 27, 1988, and deemed abandoned and void Feb. 12, 1996. The Forest Service posted the cabins in May 1996. The cabins have been abandoned to the Forest Service. There is no approved plan of operations or any other authorization for use of these cabins. Daniel and Donna Hartman located a new claim over the cabins on Feb. 13, 1996, called the Golden Hope #2; it is in a recorded status. The Hartmans have a currently approved plan of operations through Dec. 31, 2002 but it does not approve use of the cabin. The approved camp is a mobile trailer or tent.
